# Successful culvert rehabilitation with GRP segmental lining

*How OnSite supported the repair of a deteriorated twin barrel bridge culvert using GRP segmental lining*

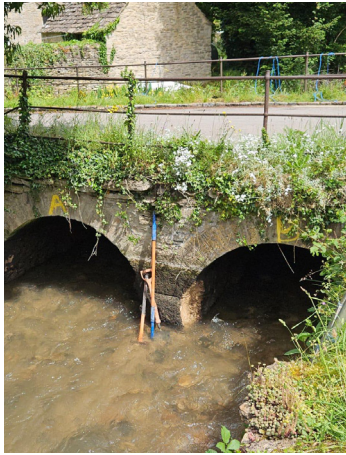
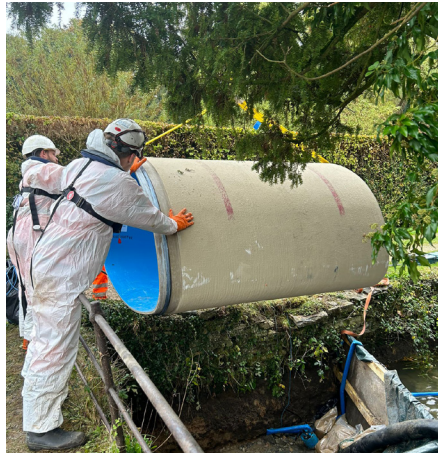
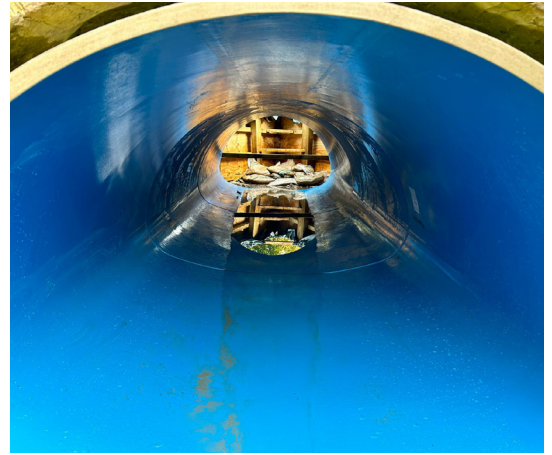
OnSite was contracted by Ringway Infrastructure to deliver a repair solution for a badly deteriorated twin barrel bridge culvert. The bridge was located over the River Coln, close to Quenington Mill.

Once the water level had been reduced sufficiently, rocks, debris and other obstructions were removed, and the culvert was then measured to ensure there was adequate space for the GRP liner to be installed.

Guide rails were fitted along the floor of the culvert to help the segments of GRP liner slide smoothly into position and maintain the correct alignment during installation. The GRP liner was then lifted from the bridge and lowered to the downstream end with a telehandler. Once in position the liner was winched

Once all GRP liner sections had been installed, they were temporarily secured with wooden wedges. The annular space between the liner and the existing culvert was sealed and filled with high-strength grout, creating a fully bonded structural lining. After the grout had set, the temporary flow diversion measures were transferred to the adjacent culvert and the process was repeated.
