Portadam Case Study

Persley WWTW Outfall

Client:
 Scottish Water via Kelda
 Water Services

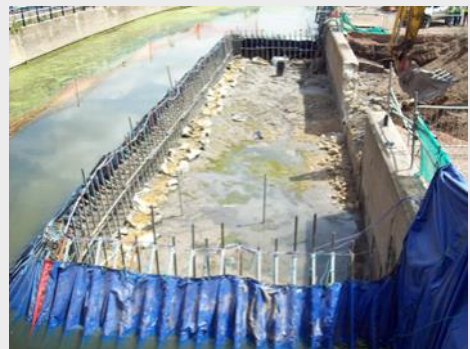
Outfall construction at the Olympic site

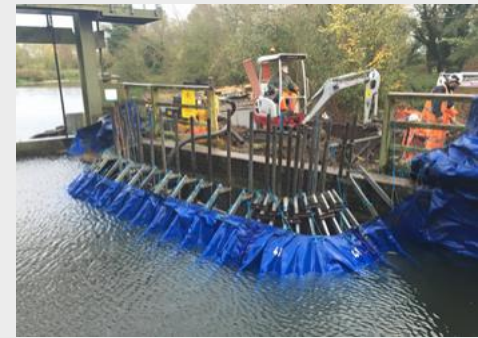
Outfall construction River Great Ouse
