OnSite provide solution for challenging engineering task with UV Lining

Client: Historic Hotel

Location: Bath

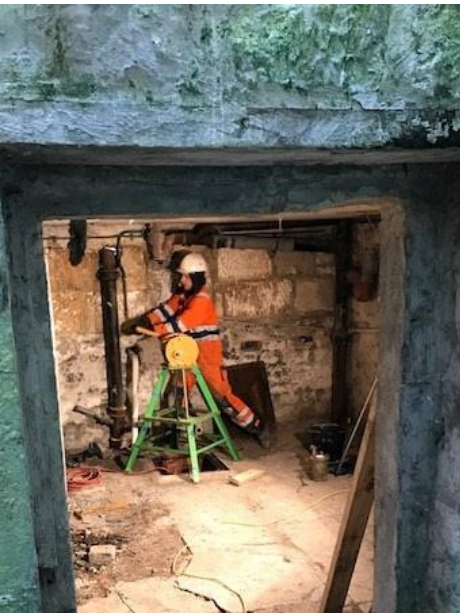
Access to upstream manhole inside the vault

The encrustation & scale within the sewer was removed using one of OnSite’s hydraulic cutting robots from the upstream manhole inside the vault. The arisings were then removed with a bespoke “pig” cleaning system which was winched through the sewer from the new tunnel access inside the coal bunker.

The liner was then manually winched into position from the new access point in the coal bunker to the upstream manhole in the vault. The UV light train was installed from the same manhole into the liner, and cured in place.
