Spiral Wound Lining (Sekisui SPR™) - Another first and exclusive for OnSite

Location: Worsley, Manchester (Under the Bridgewater Canal)

Requirement: Repairs to 6m of H2.7m x W3.1m arch brick culvert with structural failure under the Bridgewater Canal

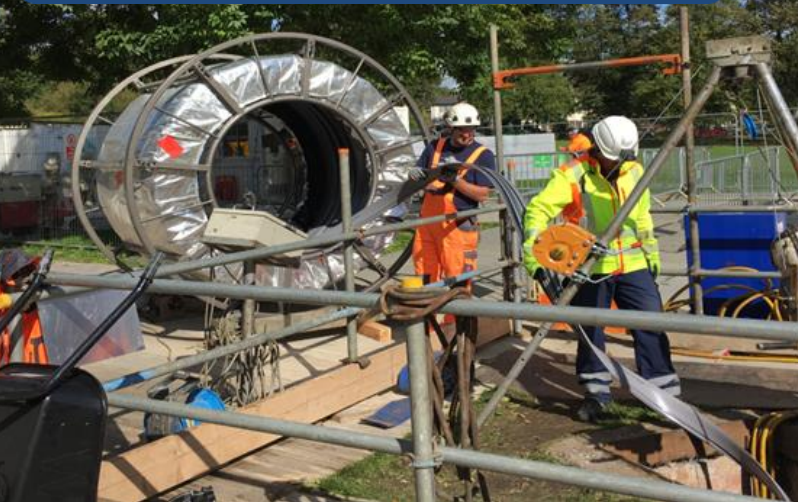
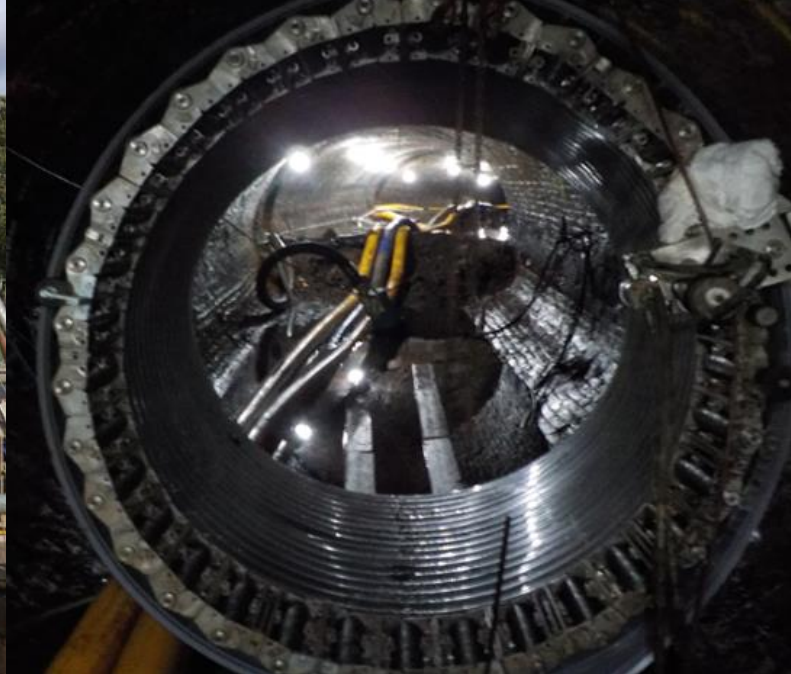
OnSite was tasked with the rehabilitation of a 6m section of arch brick culvert (2700mm wide by 3100mm high) running under an historic building. The culvert was suffering from serious structural degradation and deformation and was subject to a 4m red-carded exclusion area.

- Excavation was not an option due to the building above and adjacent canal.
- The footings of the building were on railway sleepers, which intruded into the crown of the culvert.
- The nearest access points were either side of the Bridgewater canal; a manhole 30m upstream and a sluice gate 40m downstream.
- There was a heavy build-up of silt throughout the length of the culvert exacerbated by bends in the asset.
- The culvert shape, size and access constraints hindered the use of many traditional lining methods.

Solution: Sekisui SPR™ with newly constructed transition walls at each end of the repair to reduce flow turbulence

Patented, spirally wound thermoplastic liner for gravity pipe rehabilitation.

- Applicable to ANY shape, in sizes from 150mm up to 5500mm.
- Truly no-dig with a low environmental footprint; all materials/equipment enter via manhole & are assembled in-pipe.
- The process can be temporarily suspended by cutting the profile and reconnecting later should operational conditions dictate.

- Health & Safety: OnSite could complete the rehabilitation without anyone having to enter the 4m red carded area.
- Minimal cleaning: The process of winding the pipe in situ meant that only a 12m section of culvert had to be cleared of silt as opposed to the full 70m between the access points.
- The maximum culvert capacity was maintained whilst allowing for the void & sleepers to be structurally supported.
- Construction Duration: The entire process (winding, bracing, grouting) took just over two weeks as planned.
