## Sluice Gate Repair on Scheduled Monument

**Client:** Saltford Brassmill

**Portadam enables repair and inspection to scheduled mill leats and culverts**

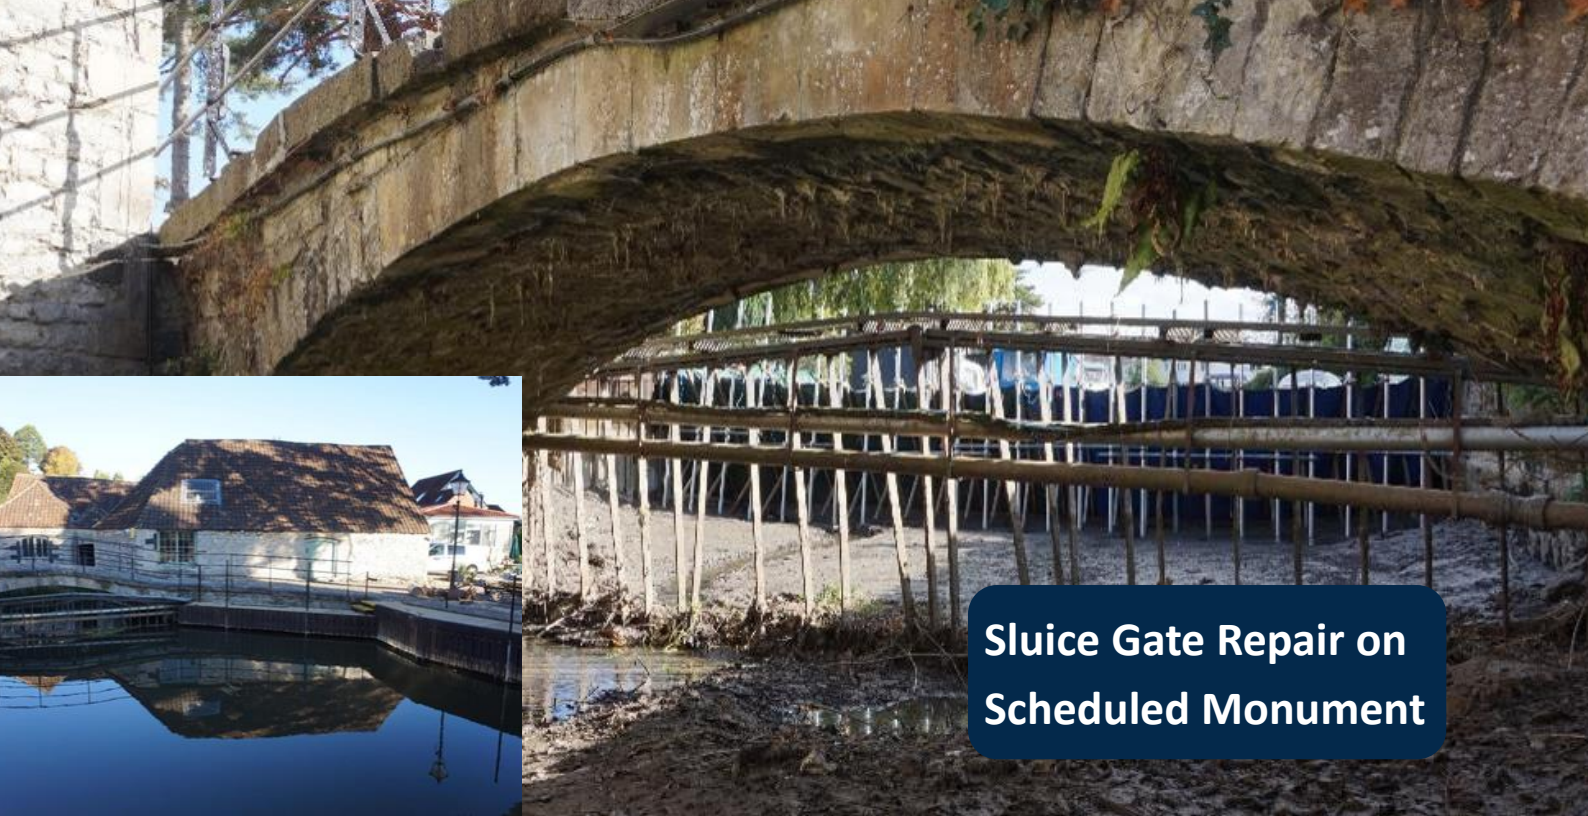
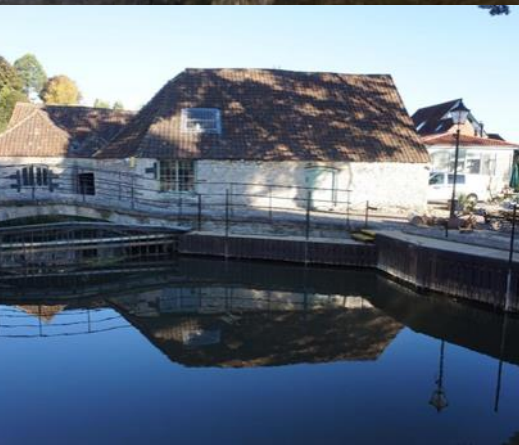
leat and de-water the mill culverts enabling the project to replace the failing sluice gate with a new one constructed by the volunteers, inspect the two other gates and conduct a full survey of the normally flooded culverts. All of the brass mill project’s short-term objectives were achieved and a future programme of maintenance work will now be developed based on the survey.

The mill, situated on the River Avon between Bristol and Bath and fed from Kelston Weir, contains five leats, three of which remain operational with functioning sluices, and one of which supports a working water-wheel. The design of the water-ways is such that there are no upstream sluices to stem flow to the mill to permit maintenance and in the past repairs would have required the river level to be lowered to the next weir, 3 miles upstream.

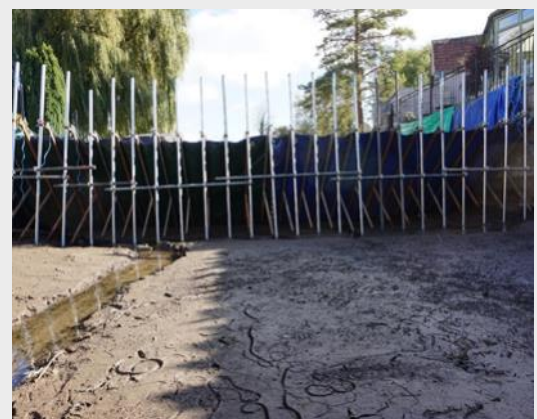
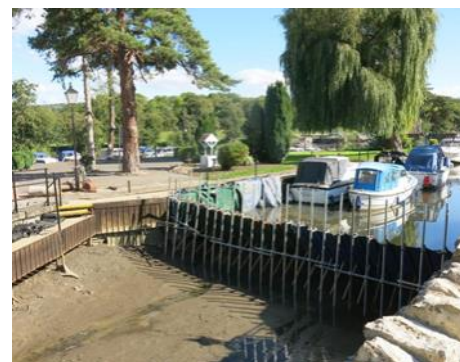
The normally flooded culverts had not been de-watered for around fifty years and one of the sluice gates was in danger of collapse. The Portadam system was used to dam the upstream

Sluice gate before and after
