Portadam Case Study

Willen Lake emergency works

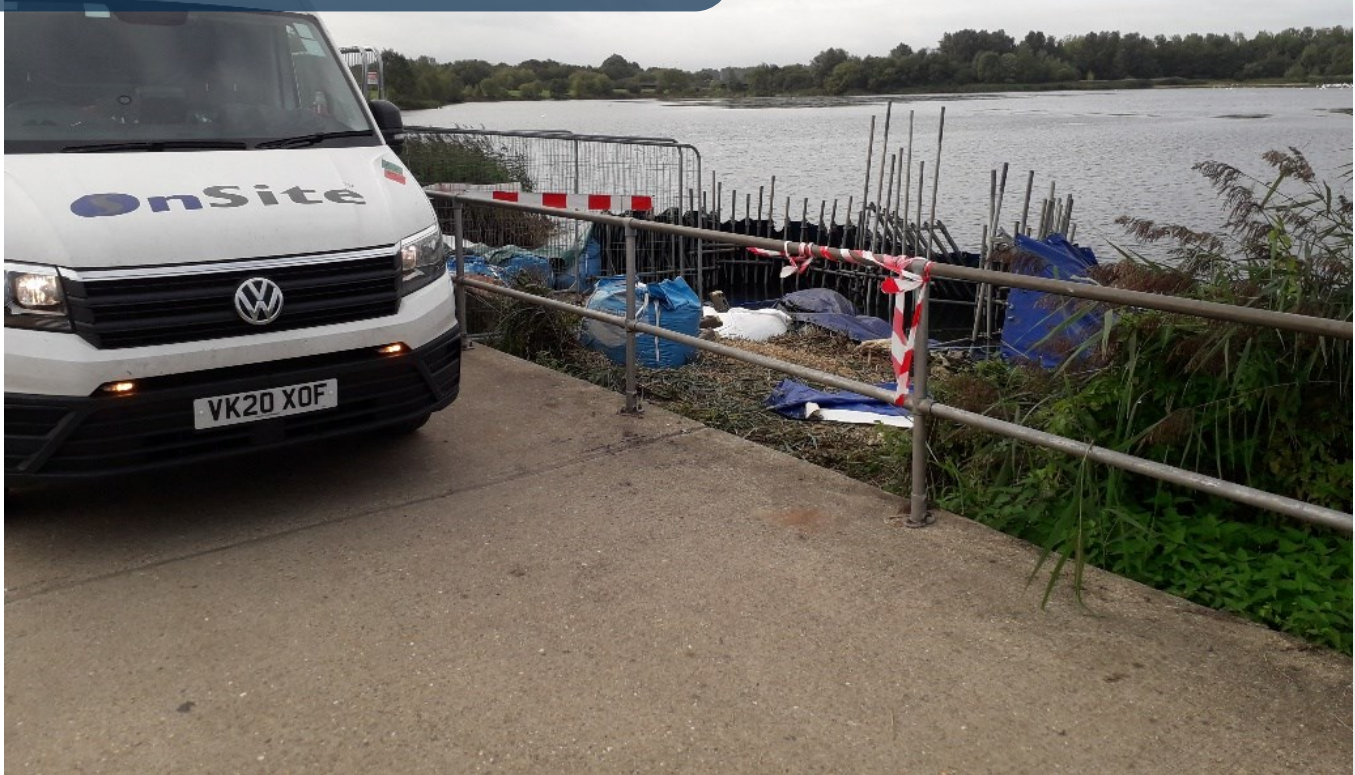
Onsite Portadam recently had an emergency call on a Friday night at 10.30pm from a client who's Reservoir penstock valve had jammed during routine yearly maintenance and operation check.

Due to the reservoir bed and structure design a set up using the full range of 2.5,2m and 1.5m frames were required.

The Portadam Installation was carried out and once de-watered the dam signed off, (after a 24 hour standing period) and the client could then start the assessment and repair works required to get the penstock operational again.
