OnSite innovations - conducting remedial works at sea

How we helped our gas rig client repair their sea eroded drainage pipelines

We were tasked with repairing the drainage system on an unmanned offshore gas rig in the Southern North Sea.

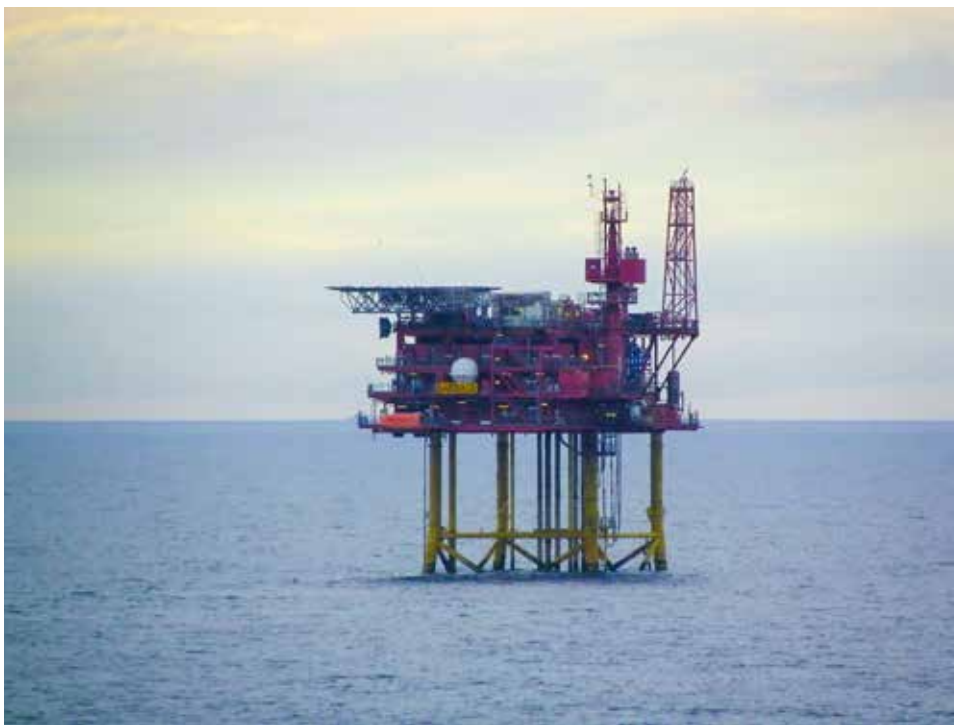
The drainage system has sections of carbon steel piping fitted that required repair after suffering internal corrosion due to being in service for 12 years. They had been initially installed with a non-corrosion resistant alloy with an original design life of only 2 years.

Internal corrosion and large loose scale deposits had caused frequent snagging and blockages. A full clean and removal along the length of carbon piping with replacement was required. Due to the location and nature of the system the Picote system was deemed the ideal solution.

Following a consultation with our experts, it was decided our brush coating offering would be appropriate for the repair and future proofing of their drainage system as the solution required less equipment and no lateral cutting to the pipework.

Brush coating offered minimal disruption, avoiding costly replacement. We are the leading certified Picote Brush Coating™ business in the UK, land or sea we are experts in the remedial use of this system. The coating provides a damp proof, corrosion resistant, wear resistant and non-corrosive lining. This was a perfect solution for sea water eroded pipelines.

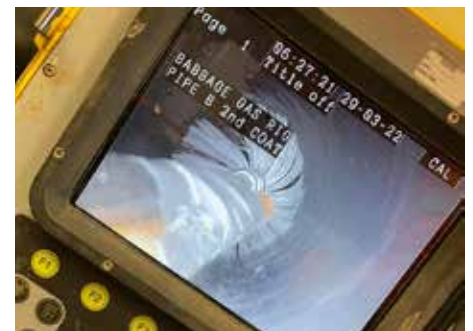
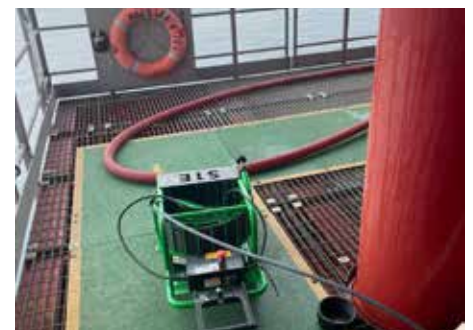
We cleaned the pipes with a high-speed rotary chain and brush tools, taking care to disconnect the pipework to the macerator prior to descale to prevent possible damage of the waste handling system.

Outside connections were uPVC piping which required further care to clean as they were hard to reach transition and mastic joints, which must remain intact.
