# Repair of shipping container platform slabs at working port

**Service/product:** Concrete repair works | **Customer:** PD Ports | **Location:** Teesport Docks

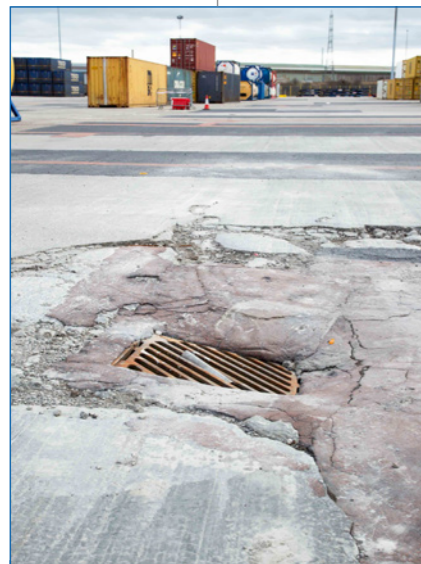
## Phase one - Project brief

The team visit the site to assess the area and establish the problem. They propose and agree a solution with the client.

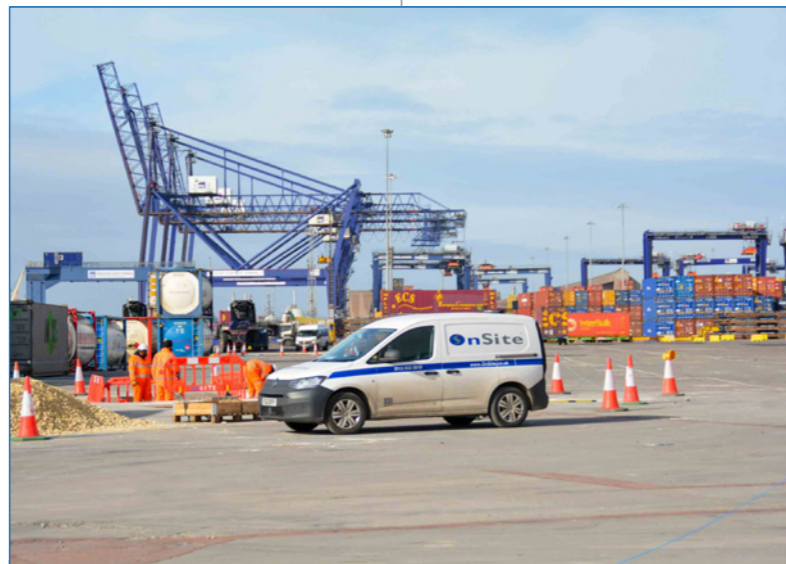
## Phase two - Project preparation

**Planning** - The team break down each element of the job and confirm the actions and resources required to achieve the project goal.

**Mobilisation** - The team complete the initial steps to get organised for the start of the project. This includes allocating storage areas for equipment and materials and arranging access to a water source.

**Traffic management system set-up** - The team work closely with the client to devise a one-way traffic system which will allow all parties to safely work alongside each other in the busy port.

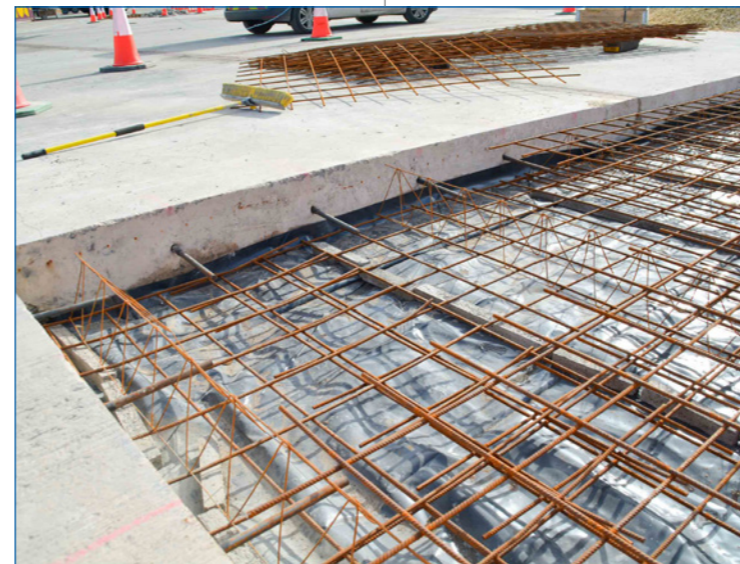
## Phase three - Full depth reconstruction

**Concrete removal** - The 300mm deep damaged concrete is removed and recycled.

**Concrete reinforcement** - A 175mm deep sub-base is put in place using compacted type one aggregate and a damp-proof membrane sheet. The concrete is reinforced with concrete block spacers and wire chair spacers. Dowels are drilled to connect the new concrete to the existing slab.

**Concrete fill** - 11 lorry loads of concrete arrive to fill the sub-base. The team use a concrete vibrator to evenly distribute the concrete before giving it an anti-skid brush finish.

**Concrete set** - The team leave the concrete to set.

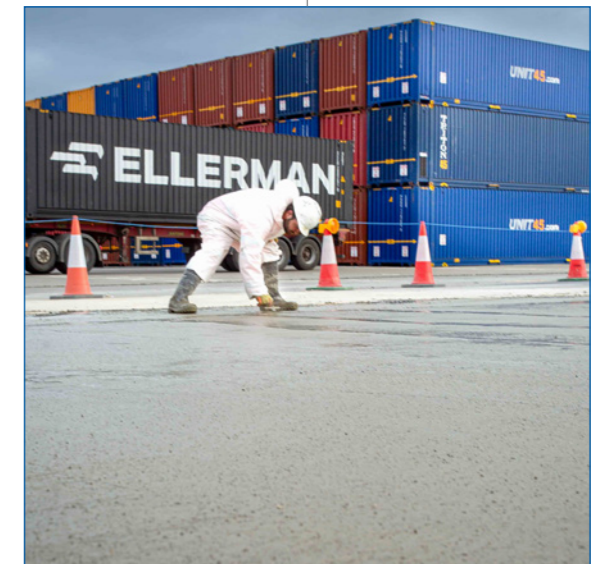
## Phase four - Testing and final inspection

**Testing** - The team conduct a concrete compression test on day 7, day 14 and day 28. The concrete reached its required strength at day 14 and the port was able to open the lane two weeks earlier than planned.

**Joint sealing** - Once the concrete has set, the 40mm deep, 20mm wide joints are filled with a flexible, waterproof seal.
