# Structural rehabilitation of a sewer network using UV lining technology

*How OnSite supported Clancy Docwra with rehabilitating a 1200m diameter sewer using UV lining.*

OnSite was contracted by Clancy Docwra to undertake rehabilitation works on a sewer under the HS2 SCS Joint Venture scheme in Ruislip, Hillingdon.

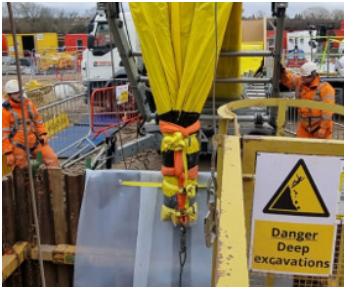
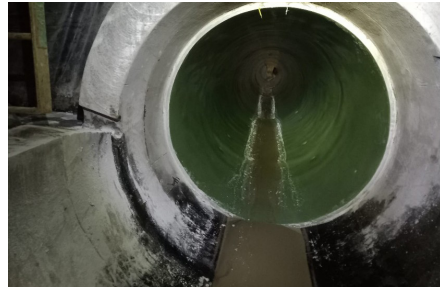
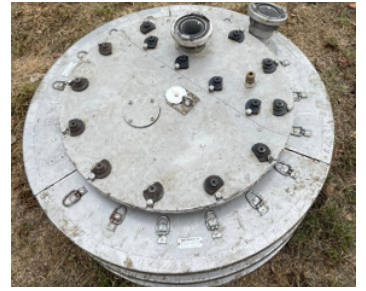
Once the liner had been delivered to site, it was positioned at the access point and prepared for installation.

It was carefully pulled through the sewer and positioned within the existing pipe.

After installation, the liner was expanded to fit tightly against the inside of the sewer. A specialist light system was passed through the liner to carry out final inspections and cure the material, forming a new structural lining within the existing sewer.

Once the liner had cured, the ends were trimmed and any remaining joints or connections were sealed using patch liners, creating a fully watertight rehabilitation solution.
