# Successful culvert rehabilitation with GRP segmental lining

*How OnSite supported the repair of a deteriorated twin barrel bridge culvert using GRP segmental lining*

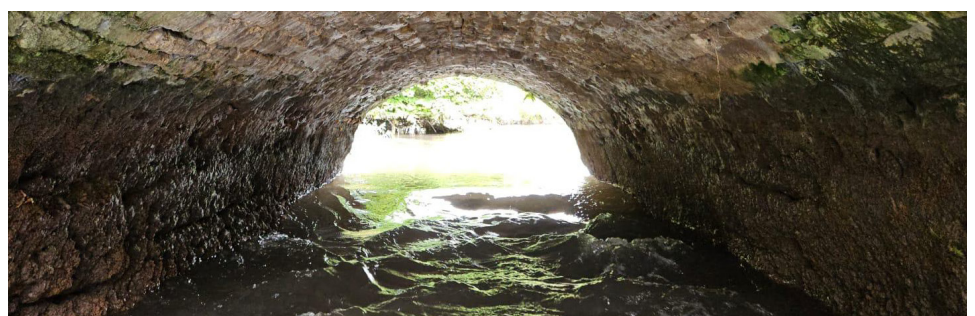
Once all GRP liner sections had been installed, they were temporarily secured with wooden wedges. The annular space between the liner and the existing culvert was sealed and filled with high-strength grout, creating a fully bonded structural lining. After the grout had set, the temporary flow diversion measures were transferred to the adjacent culvert and the process was repeated.
