Flow Monitoring Case Study

Helton Reed Bed Outflow Monitoring

OnSite's flow monitoring team recently developed an innovative low-tech, but highly successful solution to monitoring low volume flows in pipes, despite being hampered by the presence of old asbestos pipe that could not be cut due to its hazardous nature.

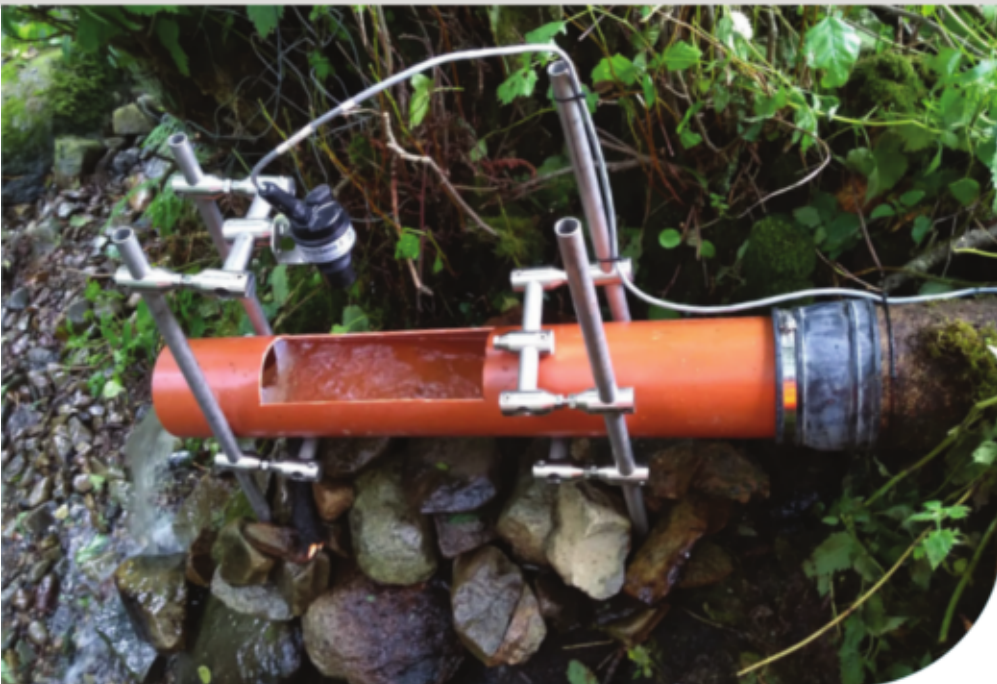
The 100mm pipe that discharges from the reed bed into the water course had insufficient flow rate for conventional flow measurement due to the low volume of the water within it.

However, close inspection of the photo supplied by United Utilities identified that the existing pipe material was cementitious asbestos, meaning OnSite would not be able to cut or break into the pipe without complex and extremely costly remediation measures.

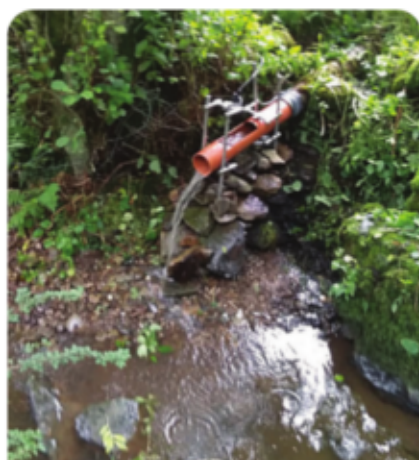
OnSite's Flow Service Delivery team collaborated with the Worcester Workshop team to develop a fresh solution that would involve extending the asbestos pipework using modern safe PVC pipe. The flow was channelled through the new section which featured a calibrated V-notch weir, enabling use of a downward-looking ultrasonic monitor to be placed directly over the extended open channel pipework.

The next obstacle was working out how the modified pipework could be secured to the old discharge pipe approximately 1.4m above the river bed. Our simple, but effective solution was to utilise the L-shaped stainless steel bars normally used for securing ultrasonic sensors into sewers. These feature adjustable hinges which allowed the pipe to be positioned at the desired gradient.

OnSite installed and commissioned the new low-tech, but extremely effective 'Flow Rig' on 27 August 2020 with data being transferred via a telemetry link directly into the new OnSite Live data portal.
