CaseStudy Pipe Jacking

Customer: Balfour Beatty

Location: Acton Town Statin, London

Project: Culvert Remediation using Pipe Jacking

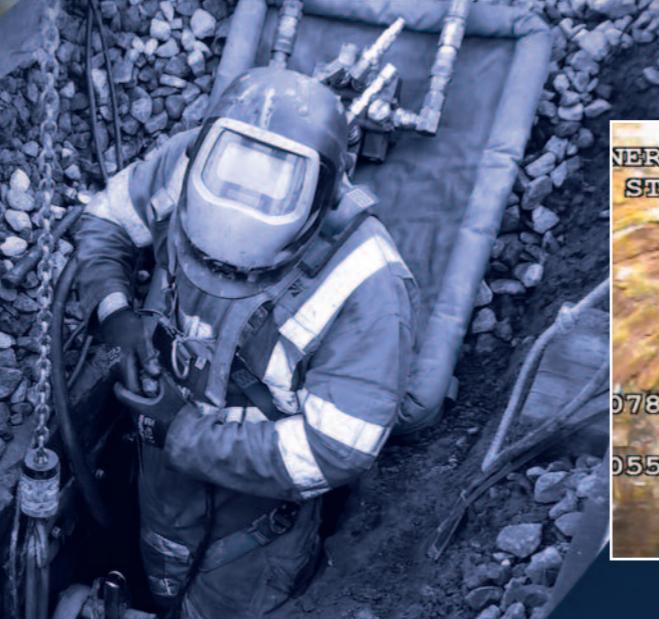
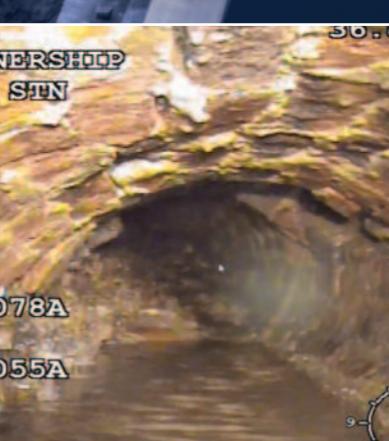
Below: Left, the brick culvert prior to remediation showing the serious deformation that precluded a CIPP lining solution. Right, the completed culvert.

In order to provide strength, without compromising the set of points that ran above the fractured section of drainage pipeline, a new 400mm diameter steel pipe was jacked into the existing 600mm diameter culvert in 1.0m sections.

Each pipe segment was jacked-in in sequence and flash butt welded at the joint. The lining process requires each segment to be welded before another segment could be added.

Due to the amount of time available at the weekend possession, another 19.0m of pipe out of the 28.4m were jacked in. The remaining 9.4m of liner was jacked-in in Engineering Hours postpossession. Finally the annulus between the brick and steel was filled with grout. Grouting seals any voids and further increases the overall strength of the remediated waste water culvert.

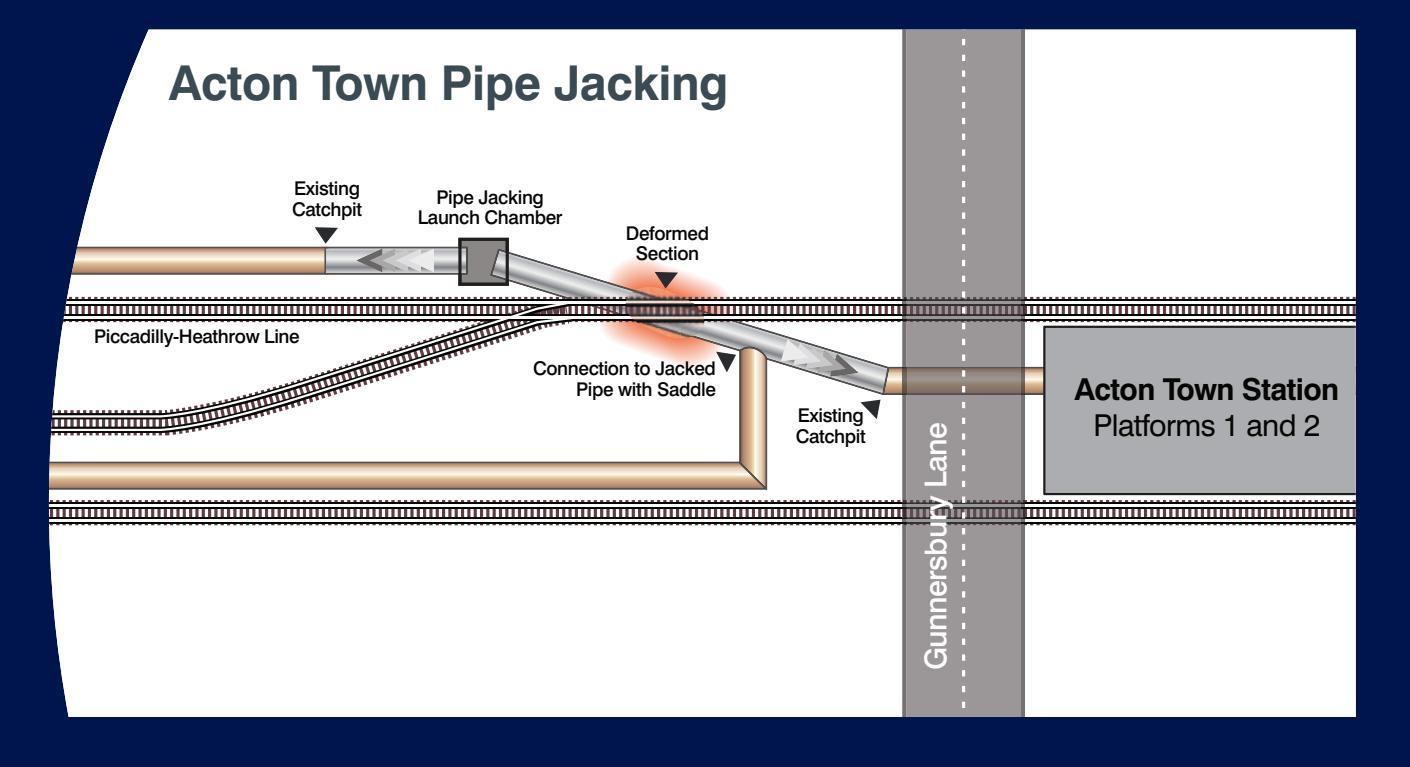
Pictured above: The Acton Town Station project combined very limited possession of a busy rail line with awkward access. As a result of OnSite's hard work, the Piccadilly-Heathrow line was closed for only 24 hours from late Saturday night, through to midnight Sunday, with final completion of associated works being delivered after the line was returned to service.

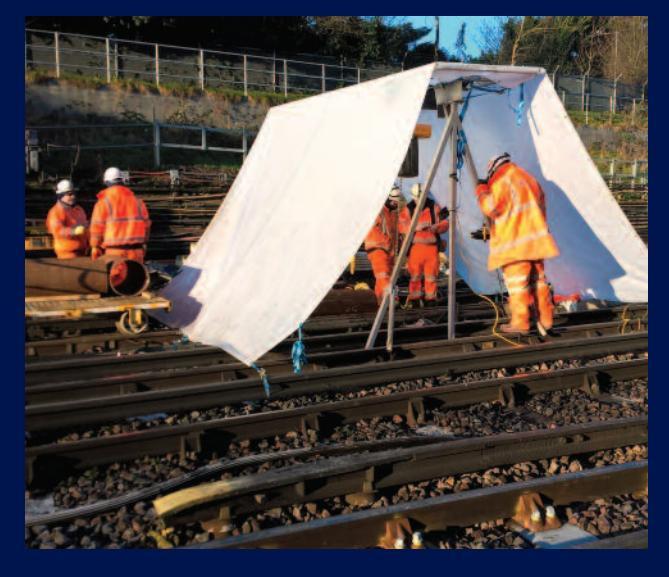
> Pictured right: The Pipe Jacking access point was located in the middle of the tracks at Acton Town. From this single access point lining pipes were jacked in both directions to existing catchpits.
