Portadam Case Study

Historic Wool Bridge collapse

Client: Dorset County Council

Portadam assists in the reinstatement of the historically important Wool Bridge

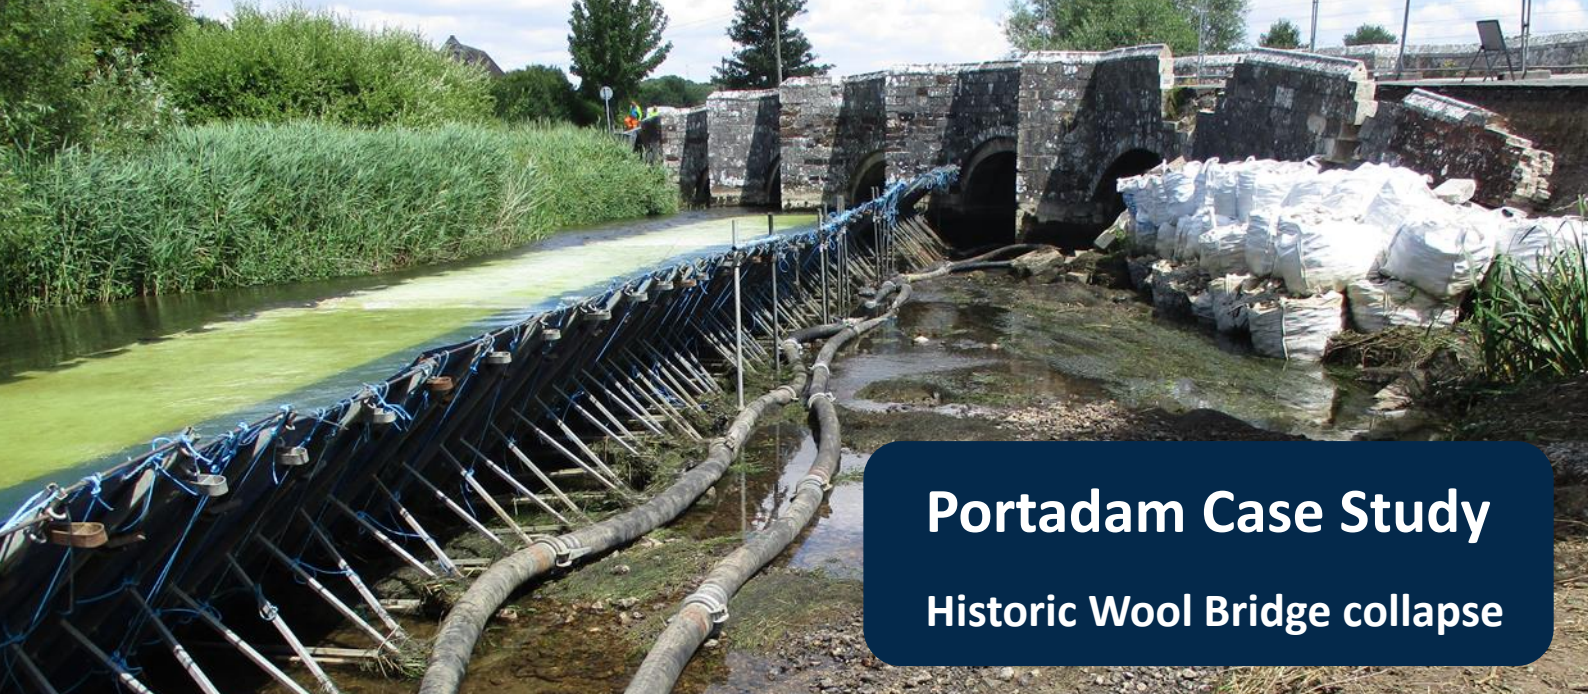
Following a partial collapse, caused by erosion of the bridge foundations , the bridge was cordoned off and aggregate bags used to prevent further collapse until repairs could be carried out.

Portadam was used to isolate the bridge whilst repairs were carried out . A row of 44, four meter, sheet piles were completely submerged to act as a wall of steel to protect the bridge from undermining by the river. These piles also support the new concrete arch and wall.

The failed section of wall and arch were rebuilt and then clad in the original brickwork

that had been recovered once the dam was in place.
