Historic canal wall rebuild for the Canal and River Trust

Service/product: PortaDam | **Customer:** Canal and River Trust

Location: Norbury Wharf, Staffordshire, UK

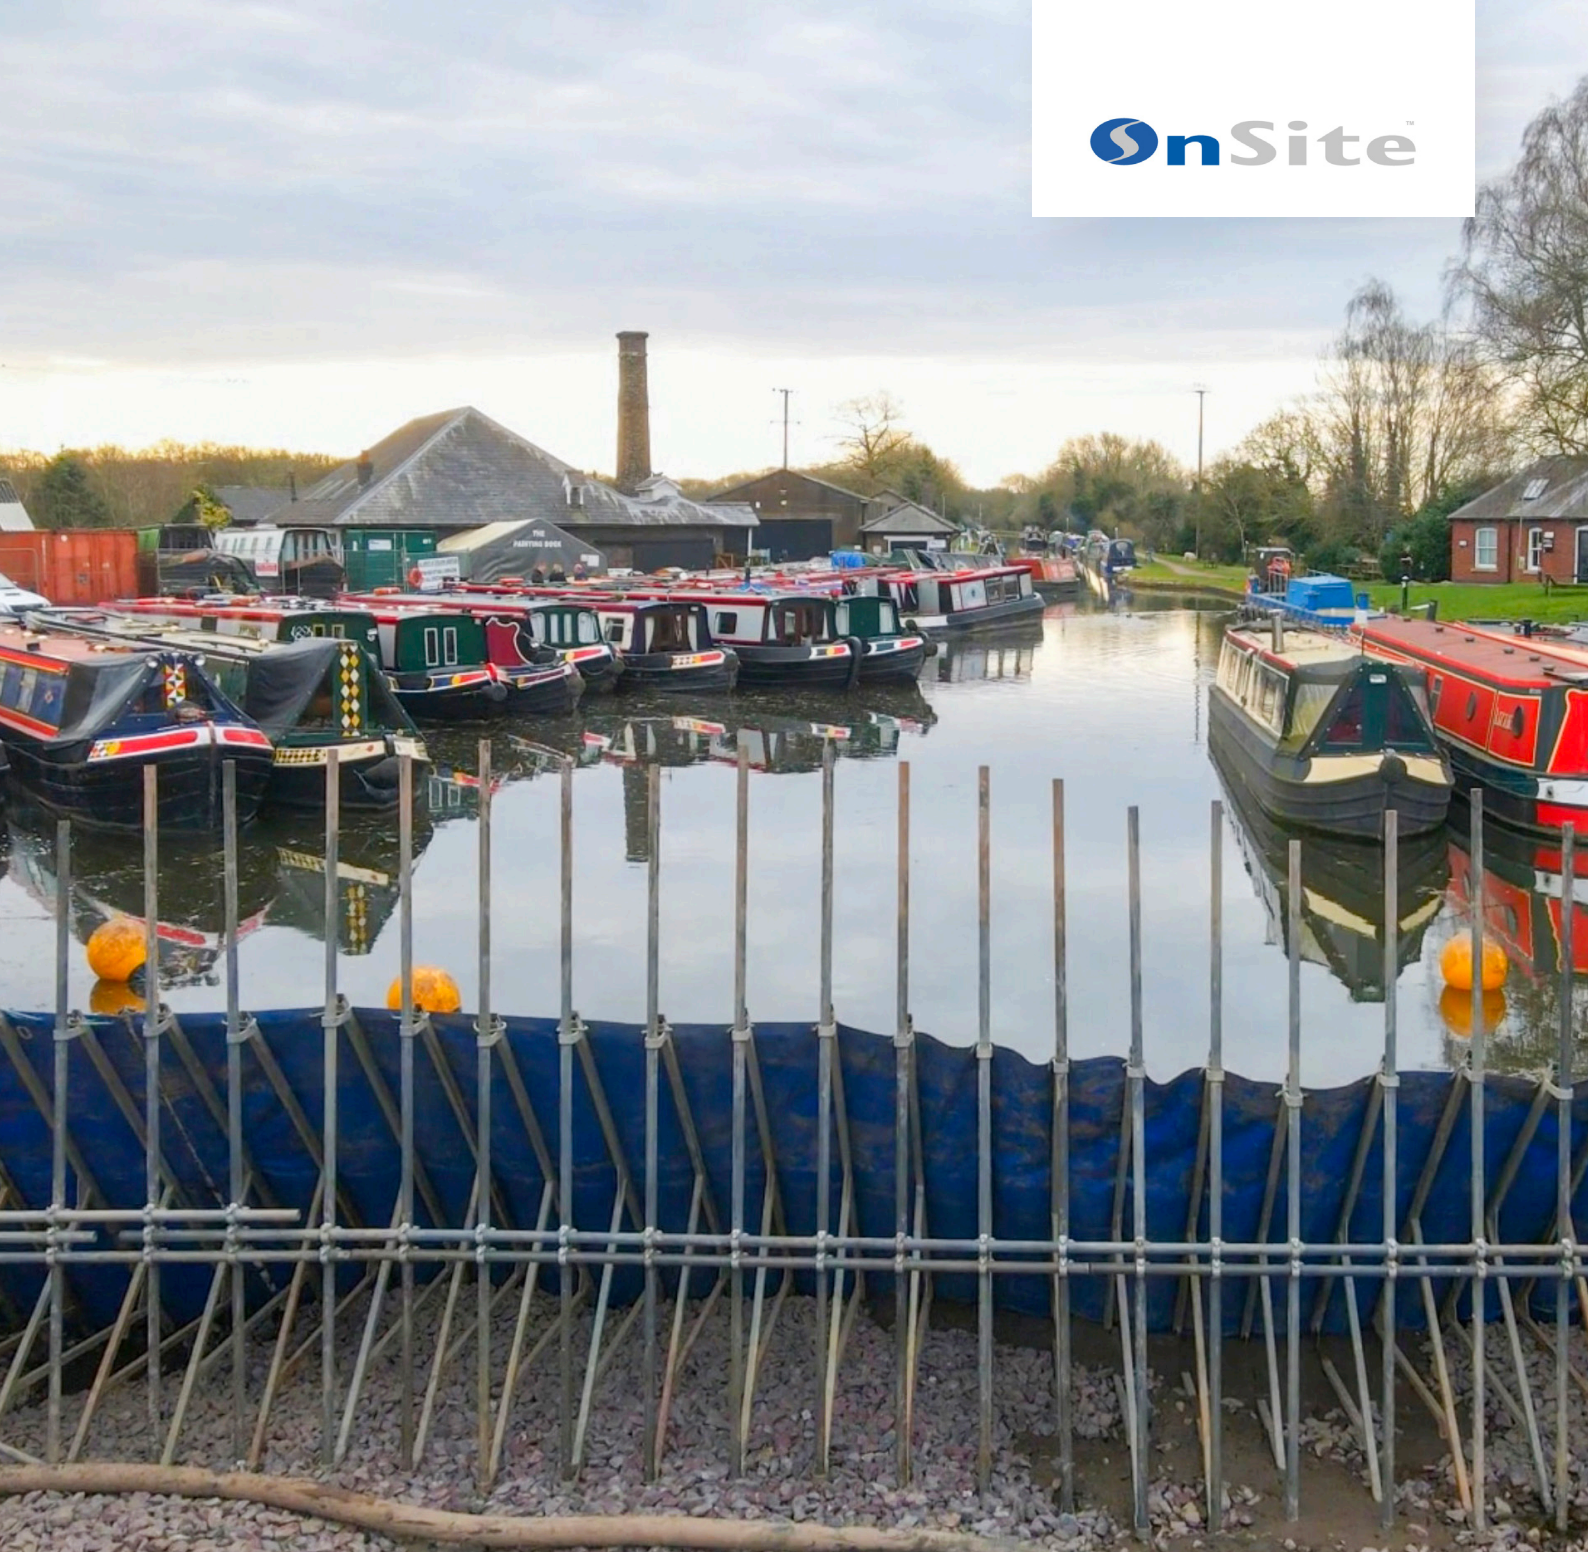
In early 2023, the Trust identified that a 20m section of the waterway wall at Norbury Junction was in a state of failure. The wall had sunk and was leaning into the canal on the north corner of the wharf.

PortaDam successfully holding back the water to create a safe and dry area to work in.

OnSite were called in by the Trust as part of their framework, firstly to PortaDam the area, before the deconstruction and rebuild of the wall.

On starting the work, the OnSite team discovered that the canal depth was greater than expected. This required an additional 150 tonnes of stone to be installed to the canal bed to create a firmer surface.

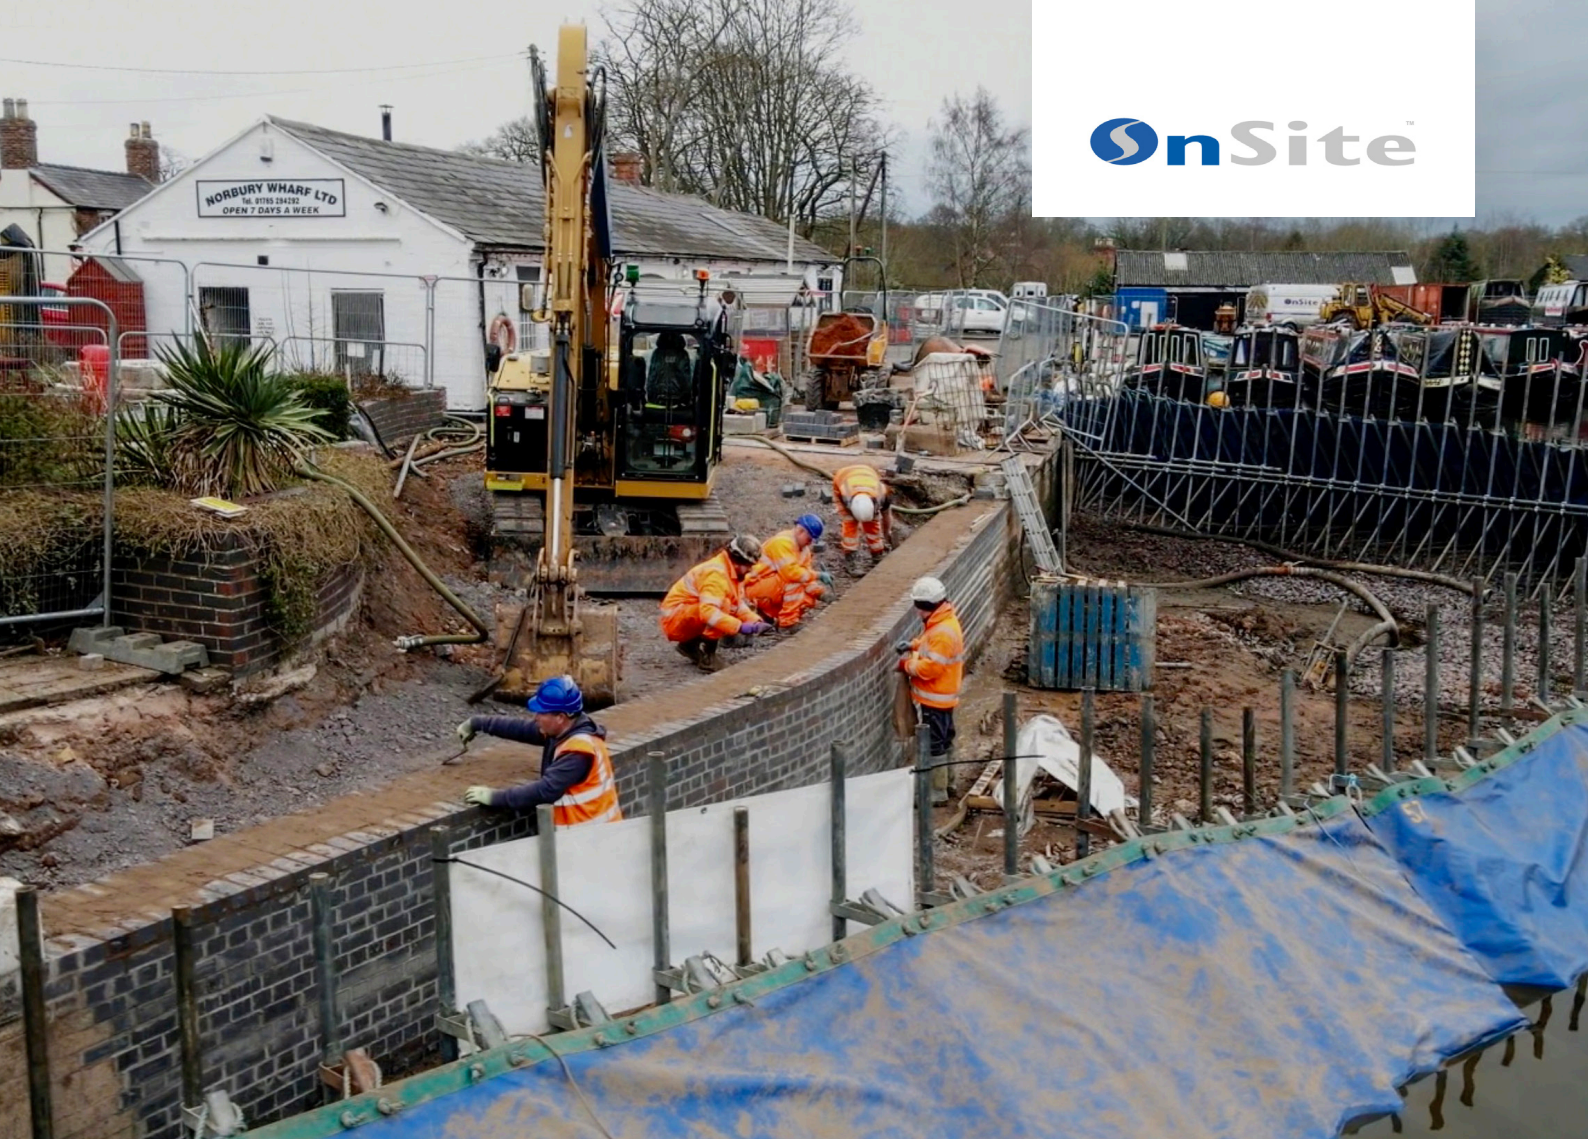
Workers rebuilding the new brick built wall behind the protection of PortaDam.

A heritage advisor was consulted to approve the type and colour match of the bricks used to rebuild the wall although the team reused the original bricks where it was possible to do so. The wall also had to be constructed in the same brick bond as the original.

The existing concrete copings were numbered as they were removed so they could be put back in their original layout.

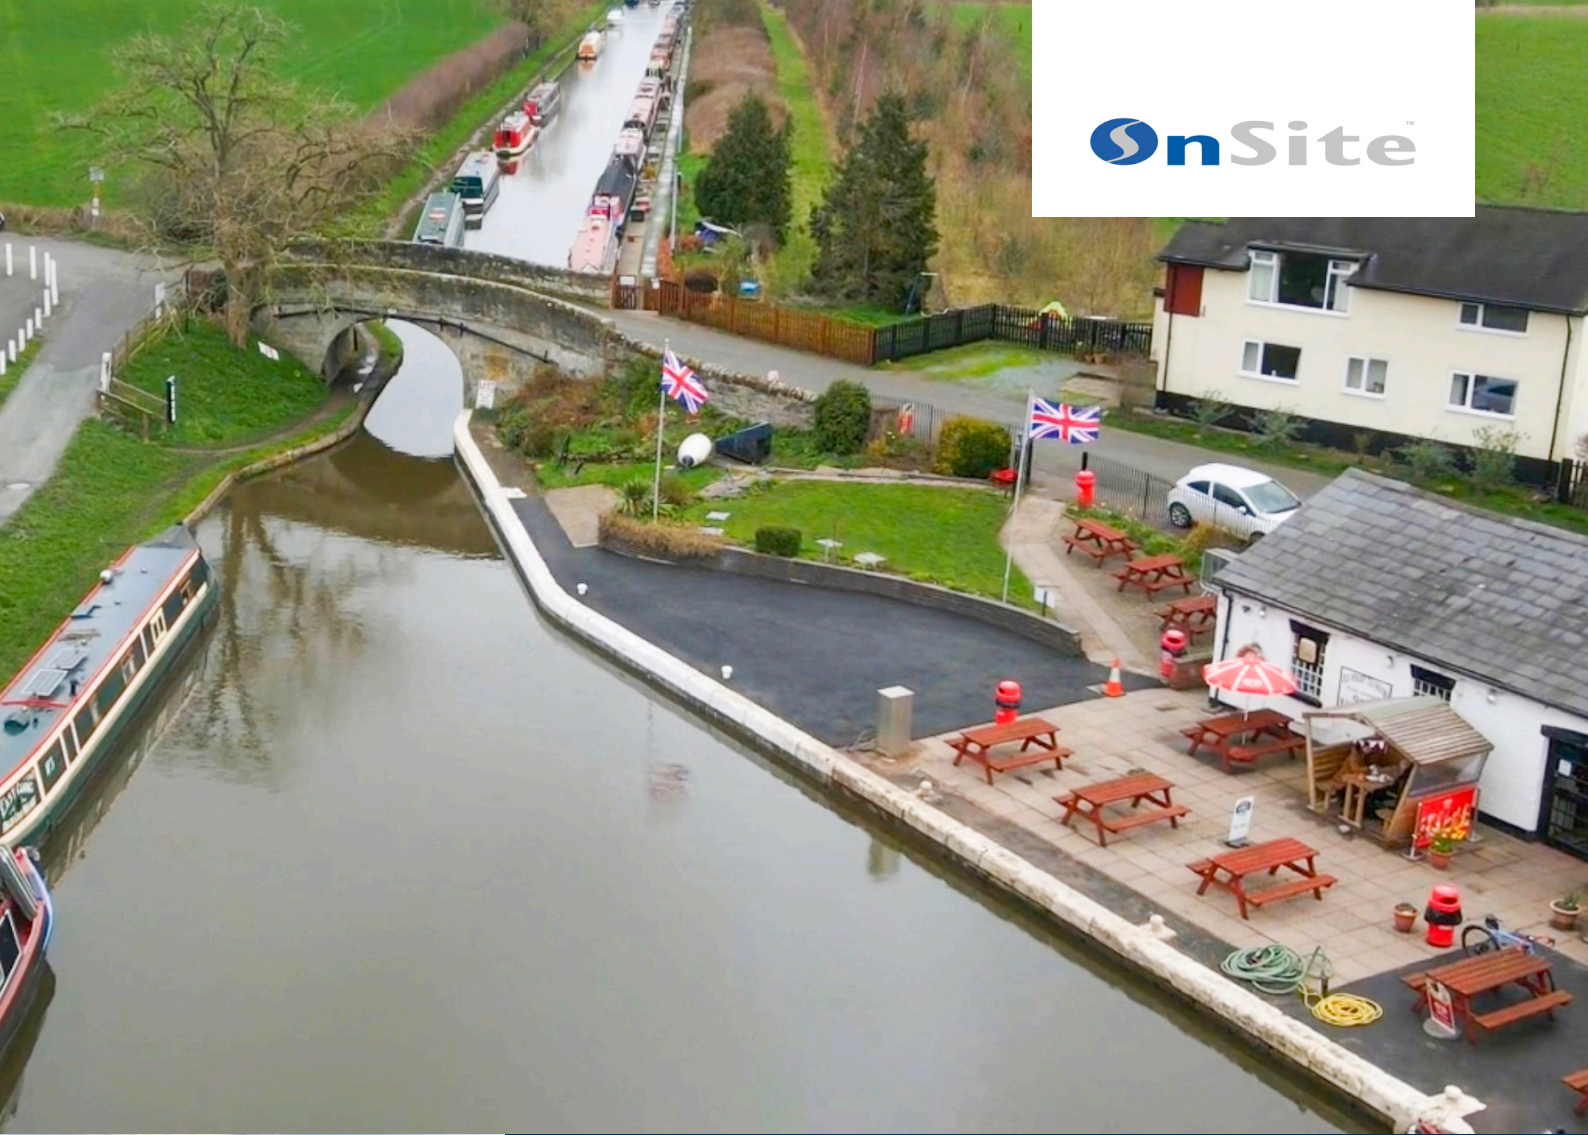
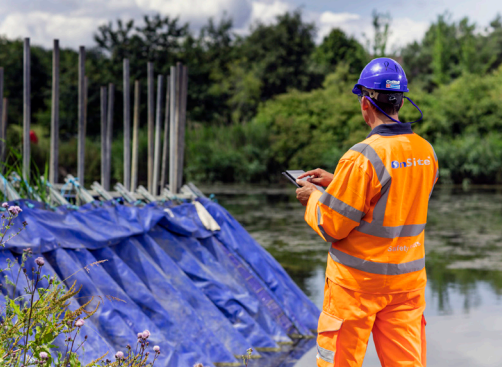
PortaDam | temporary dam system

Designed, engineered, and tested for the specific purpose of constructing a barrier to hold back water. It creates an effective temporary dam, providing a safe and dry area for maintenance, inspection and civil construction works in waterways, rivers, canals reservoirs and docks.
