Culvert maintenance works for the Canal & River Trust

Service/product: Culvert maintenance | **Customer:** Canal & River Trust | **Location:** Gargrave, Skipton

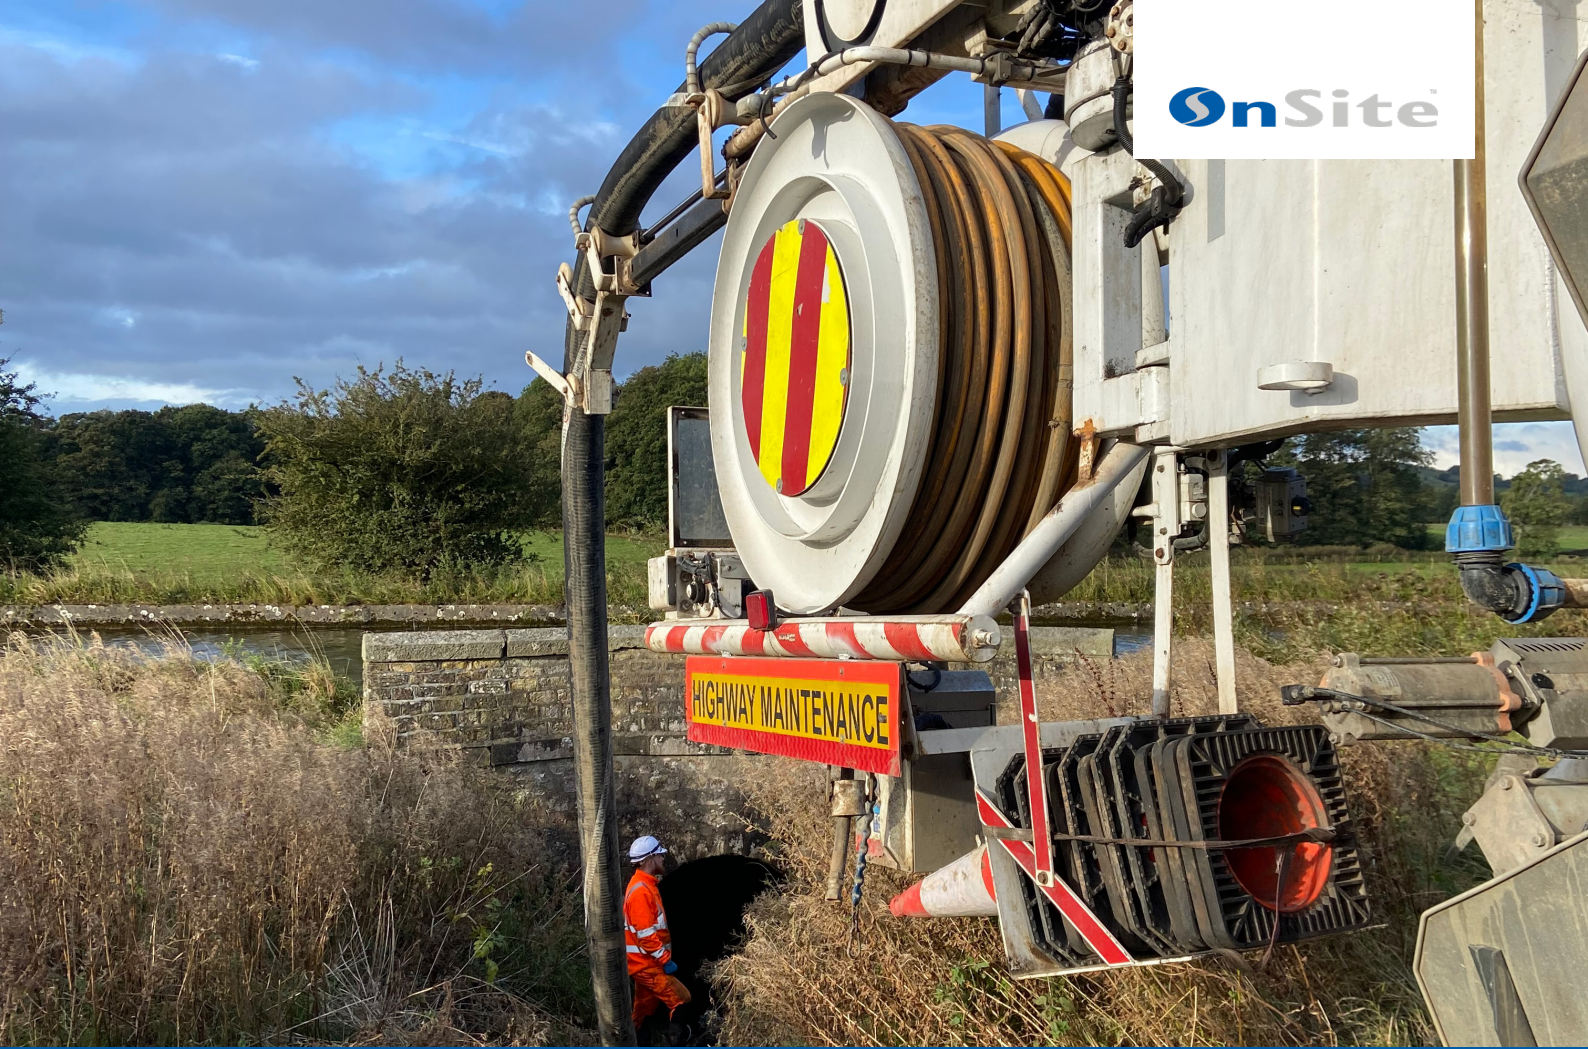
The culvert was located under a canal on private farmland which made the area difficult to access using traditional equipment, but the team were able to use OnSite's 8x8 full wheel drive combination high pressure water jetting/suction unit with integral water recycling to safely access the site and complete the cleaning element of the works.

To prepare for the cleaning, the culvert was de-watered and over pumping from the outlet was established to re-direct the normal flow. A simple, temporary sandbag dam (400mm high x 2,000mm wide) was also constructed on the culvert inlet to ensure no release of waste during the works.

The silt inside the culvert was tested to determine if it should be disposed of through a licensed waste disposal facility, before the team carried out High-Pressure Water Jetting (HPWJ), removing and disposing of 75% volume of silt from the culvert.

Once the culvert had been de-watered and cleaned, the team completed a CCTV condition inspection survey before making ready for a man entry inspection by the client.

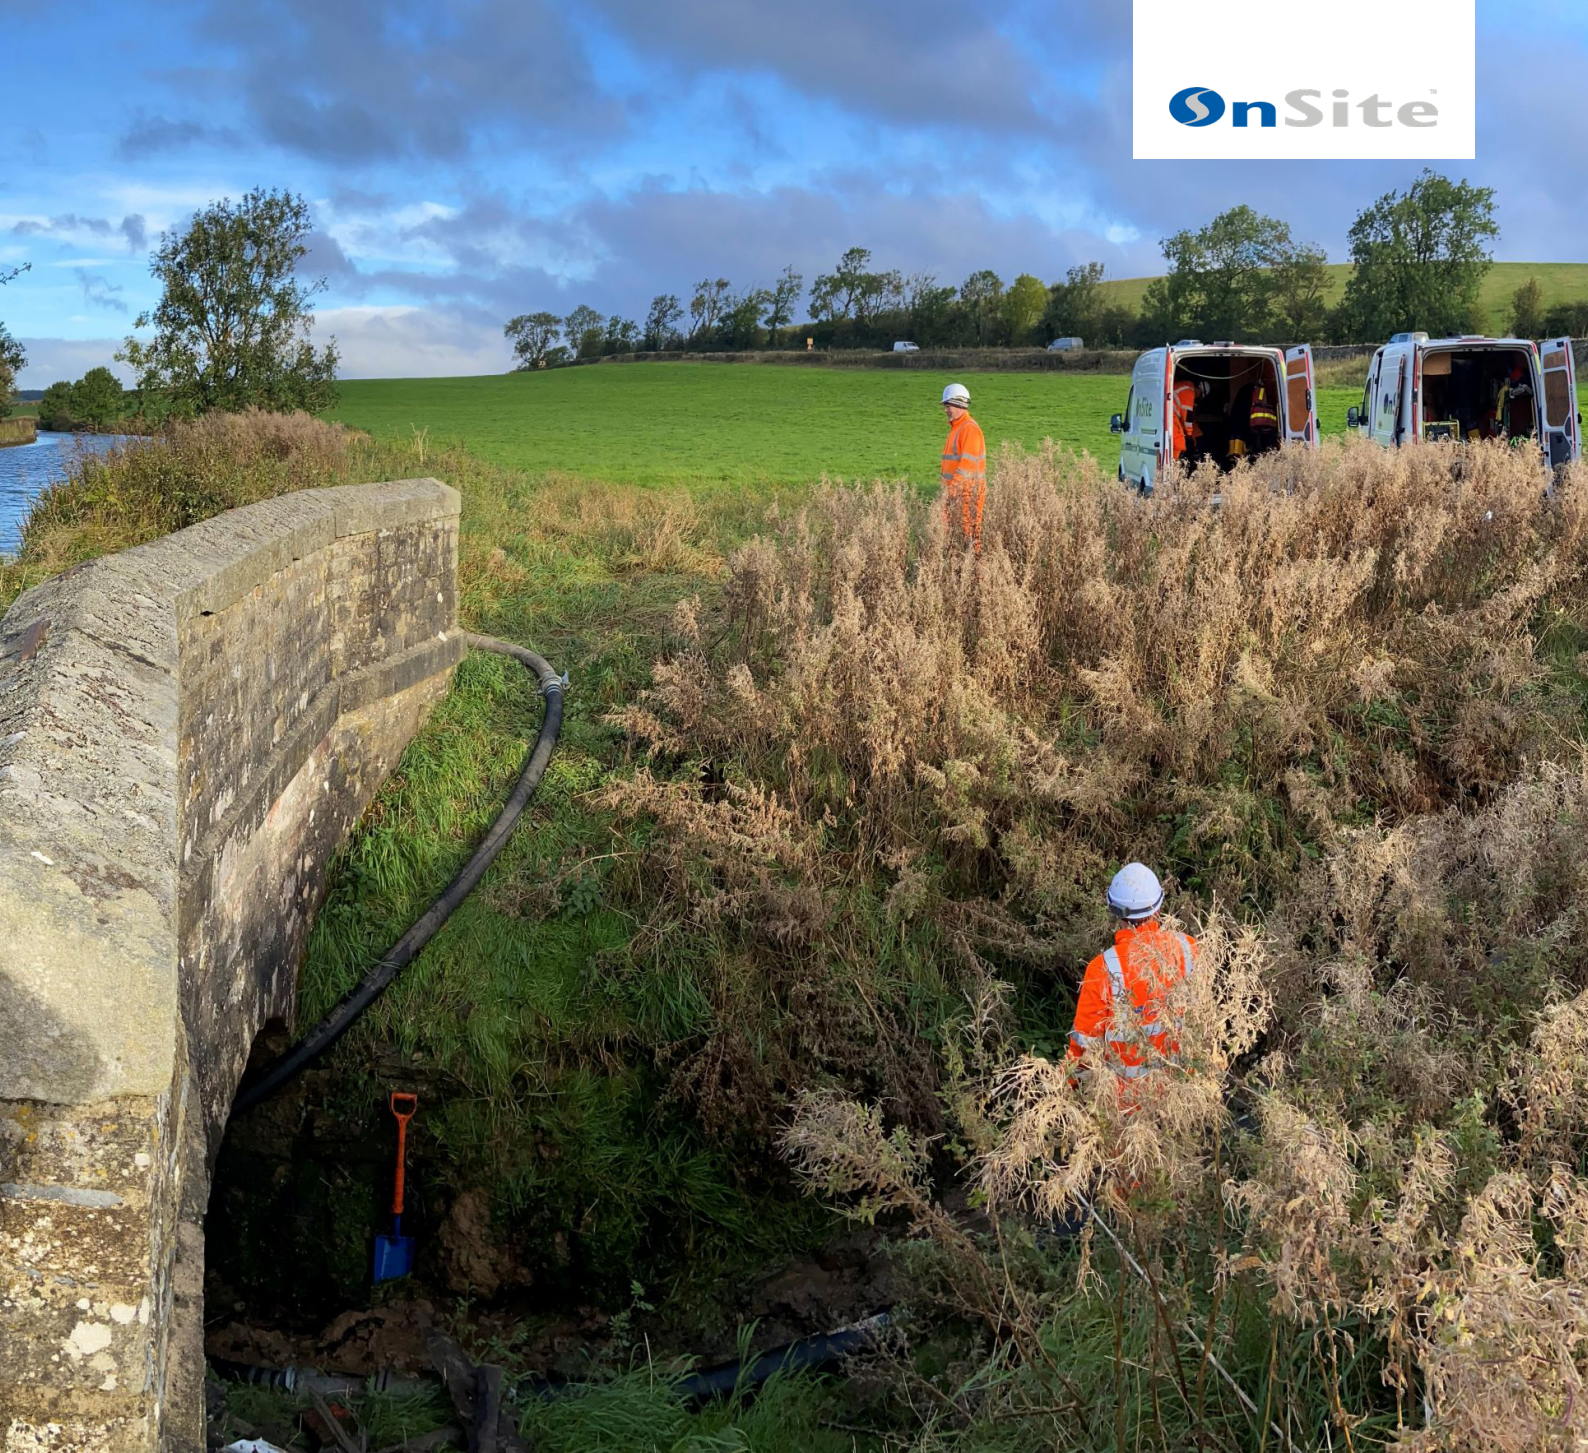
Culvert details

Shape:
Oval

Dimensions:
1,850mm height
x 1,900mm width

Length:
25mtr

Design:
Siphon

Material:
Masonry
